**Re: Class 2 Updated Reserve Fund Study
Niagara North Vacant Land Condominium Corporation No. 232**

CLASS 2 UPDATED RESERVE FUND STUDY

**NIAGARA NORTH VACANT LAND
CONDOMINIUM CORPORATION
NO. 232**

SANDALWOOD COMMON & BLOSSOM COMMONST.
CATHARINES, ONTARIO

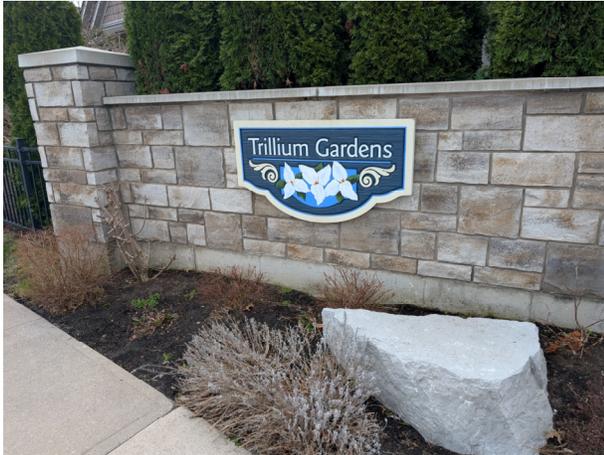
Photograph 01

The property is a vacant land condominium development comprised of roadways, visitor parking areas, landscaping and perimeter fencing for a 53-unit residential complex located on Parkside Drive in St. Catharines, Ontario. The site was registered on April 26, 2013.

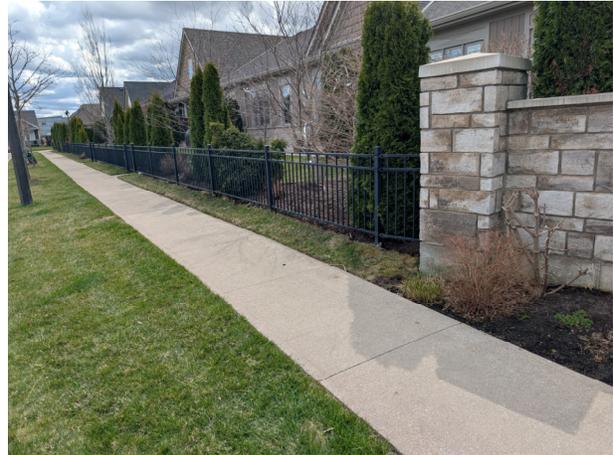
Photograph 02

A three-foot prefinished metal fences are installed along the north property line (facing Parkside Drive). The metal fences were found in good condition except for minor bent rails noted at the north-west corner of the site. The Reserve Fund Study has included an allowance for the replacement of the fencing every 30 years.

Masonry entrance features consisting of walls and piers are installed at the main roadway entrances to the site. Decorative signage has been secured to the walls. The masonry features were found in good condition overall. The Reserve Fund Study has included for the as-needed repair of the masonry features every 10 years.

View of the metal fencing and masonry entrance features.

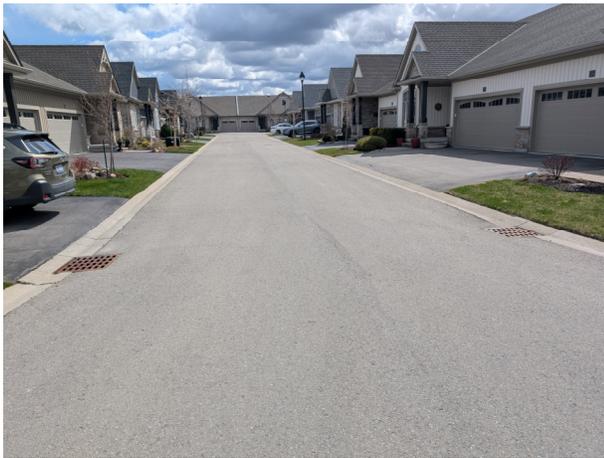
Photograph 03

The access roadways for the development are paved with asphalt. Access to the site is provided by multiple entrances from Parkside Drive. Visitor parking is provided at designated locations throughout the property. The asphalt roadways were found in fair condition overall except for minor cracks noted in isolated areas.

Concrete curbs have been installed along the perimeter of the asphalt roadways and parking areas. The concrete curbs were found in good condition overall except for minor cracks and physical damage noted in isolated areas. The Reserve Fund Study has allowed for the repair of damaged areas (not full replacement) to be undertaken during asphalt replacement.

View of the asphalt roadway and concrete curbs.

- Removal and replacement of the asphalt and localized repairs to the sub-base approximately every 20 years.
- Localized asphalt repairs every 5 years.

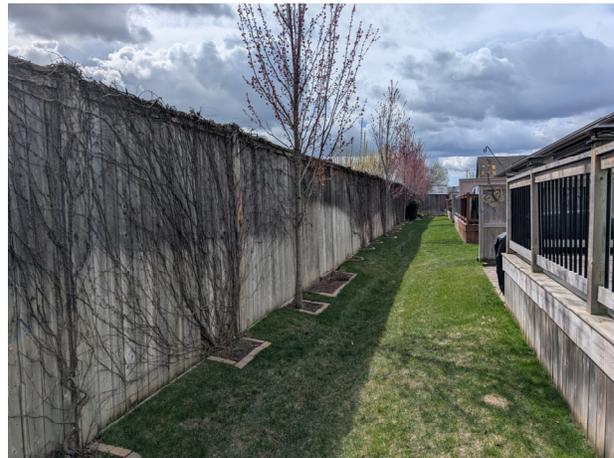
Photograph 04

The east, south and west perimeters of the site are enclosed with pressure treated wood fences. Details on the drawings indicate these were designed as noise attenuation fences (noise barriers). The wood perimeter fencing was noted to be in fair condition with weather minor dust and water stains.

View of the wood perimeter fencing.

The Reserve Fund Study has included a general allowance for the replacement of the wood perimeter fence approximately every 25 years.

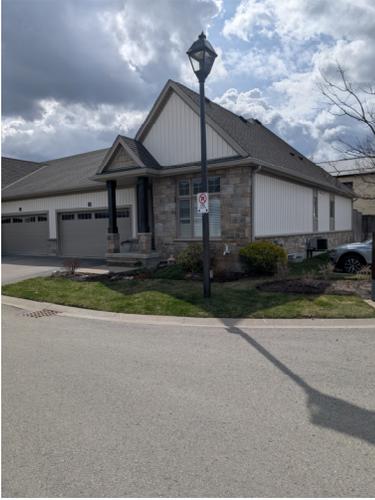
Photograph 05
View of the lamp standards.

Maintenance and repair of the light fixtures and standards should be handled under the operating budget. Replacement of the lamp standard (poles and fixtures) has been included in the Reserve Fund Study every 30 years.

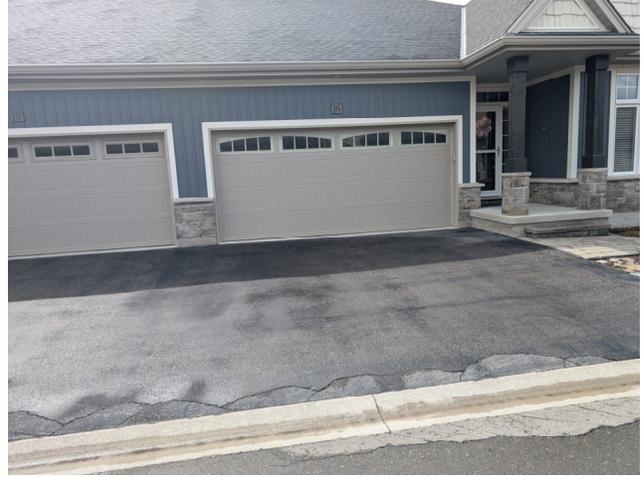
Photograph 06
View of the asphalt driveway.

The Reserve Fund Study has included for the replacement of asphalt paving at the driveways approximately every 15 years.

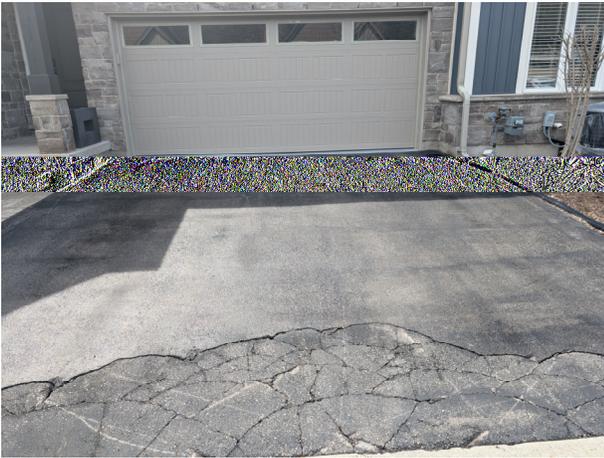
Alligator cracks were noted on various driveways during our site review. Repairs are scheduled to occur in the coming fiscal year.

Photograph 07
View of the damage to the asphalt driveway.

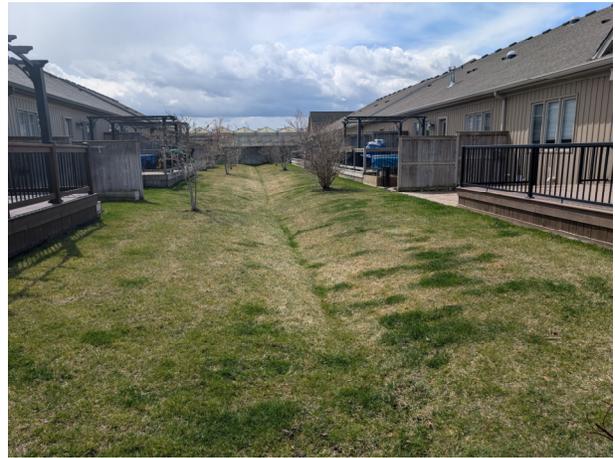
Photograph 08
View of the landscaping.
